Report No. UT-17.02

TYPICAL AND DARKENED PORTLAND CEMENT CONCRETE PAVEMENT: TEMPERATURE, MOISTURE, AND ROUGHNESS ANALYSES

Utah Department of Transportation
Research Division

Final Report
January 2017

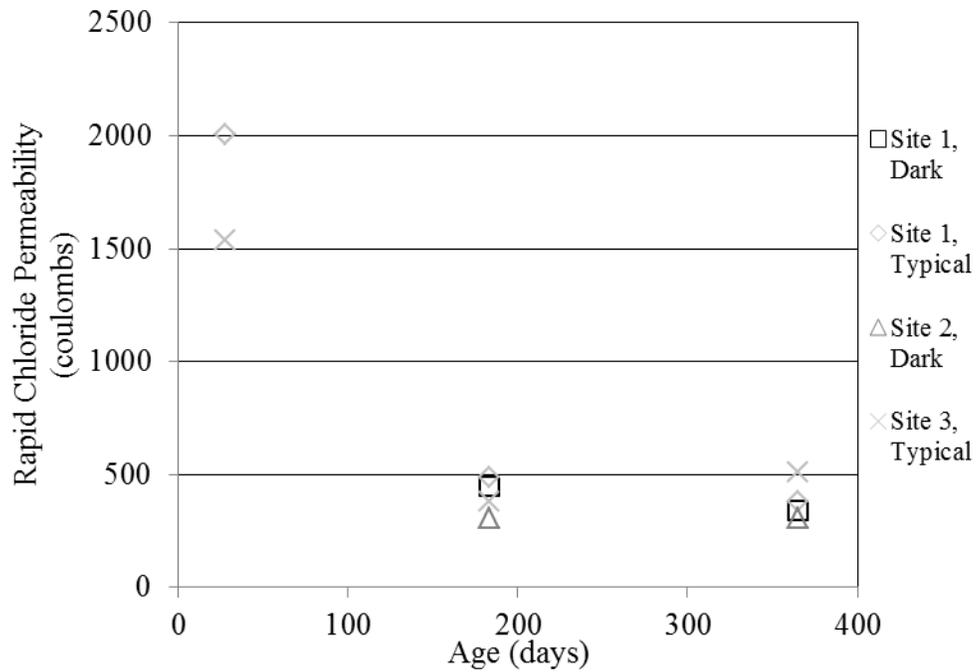
Figure 4-19: Rapid chloride permeability.

Figure 4-19 shows average rapid chloride permeability values. Specific sample rapid chloride permeability values and classifications are given in Appendix B. As expected, chloride permeability decreases over time. At 28 days, both concrete types were classified as having “low” permeability, while at all testing times beyond 28 days, both concrete types were classified as having “very low” permeability. On average, the darkened concrete was less permeable than the typical concrete by 119 coulombs, or 26.8 percent, at 1 year.

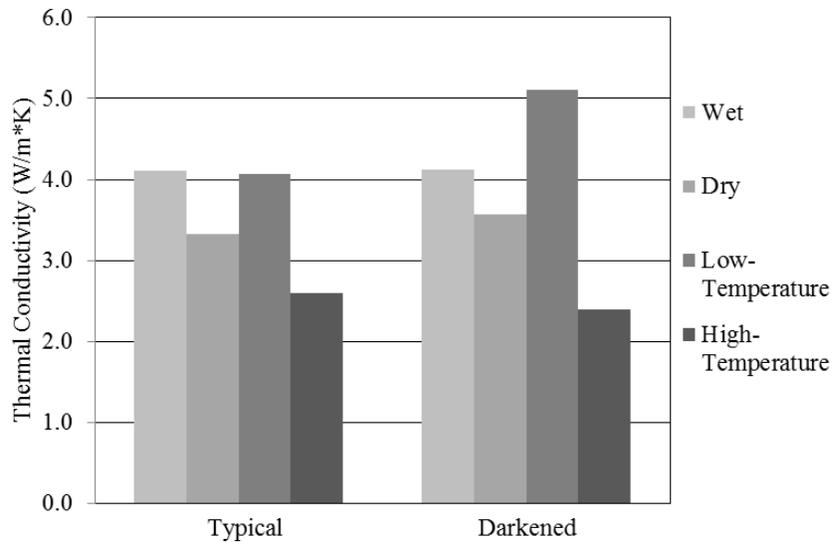
Figure 4-20: Average thermal conductivity.

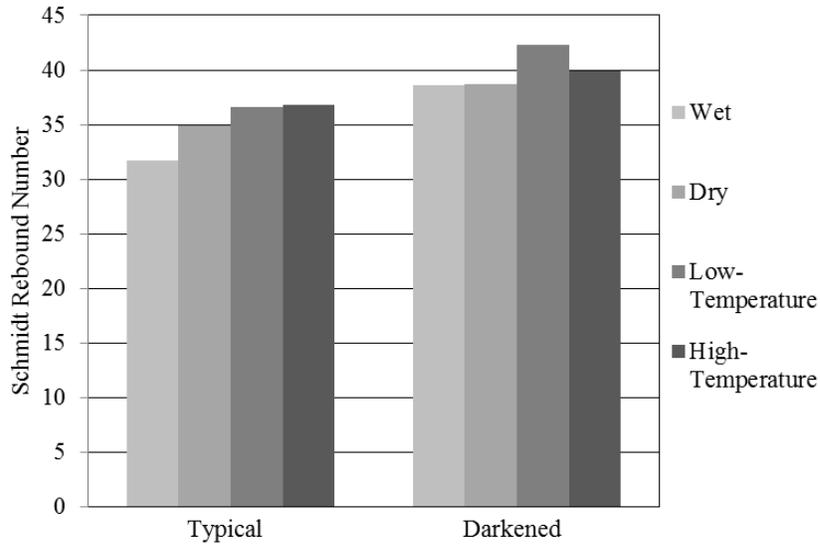
Figure 4-21: Average Schmidt rebound numbers.

Figure 4-21 shows the average Schmidt rebound numbers. On average, the Schmidt rebound number of the darkened concrete was higher than that of the typical concrete by 4.9, or 13.9 percent. This result is consistent with the compressive strength test results presented earlier.

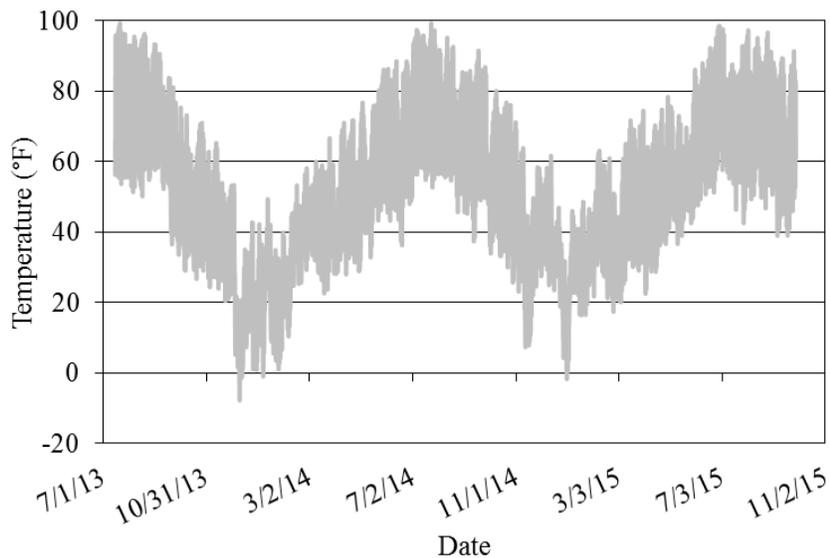
Figure A-19: Air temperature from environmental sensor.

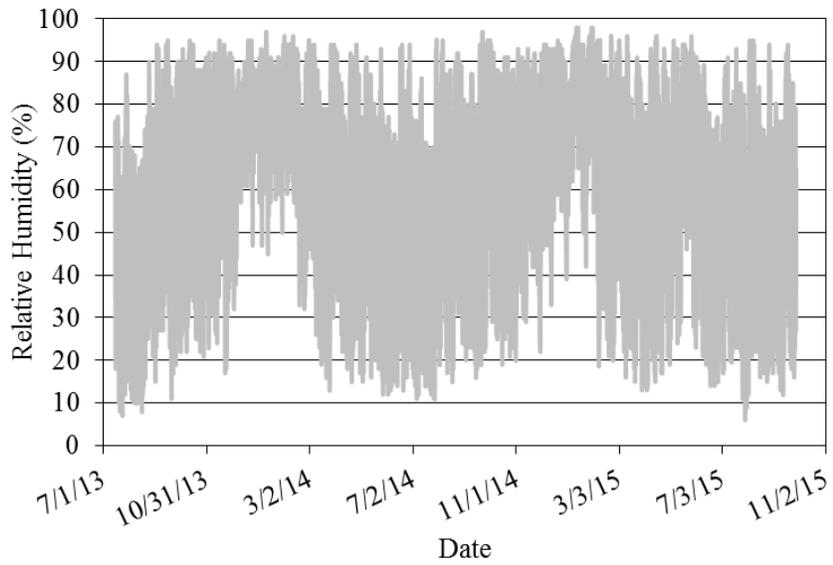
Figure A-20: Relative humidity from environmental sensor.

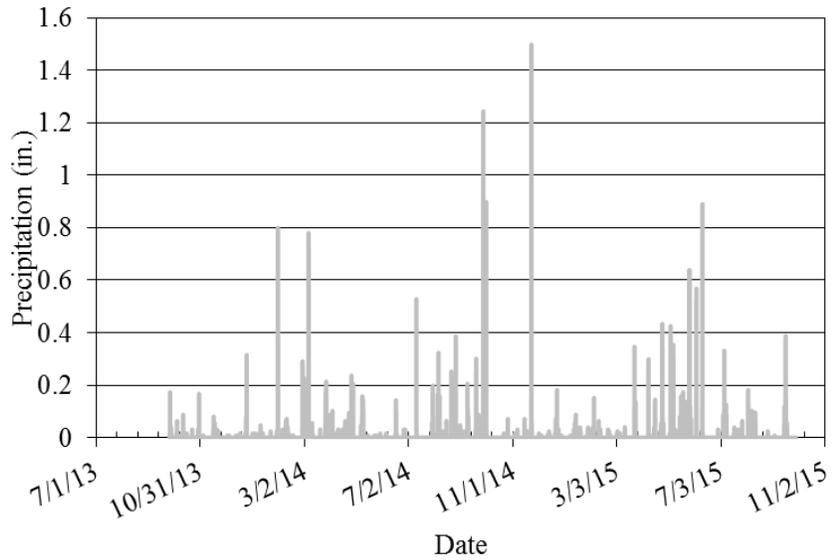
Figure A-21: Precipitation from environmental sensor.

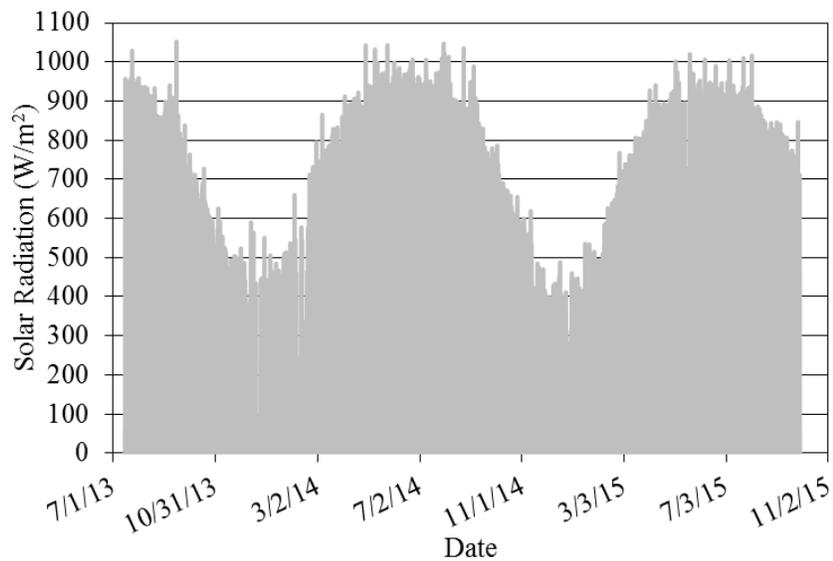
Figure A-22: Solar radiation measurements from Campbell Scientific, Inc.

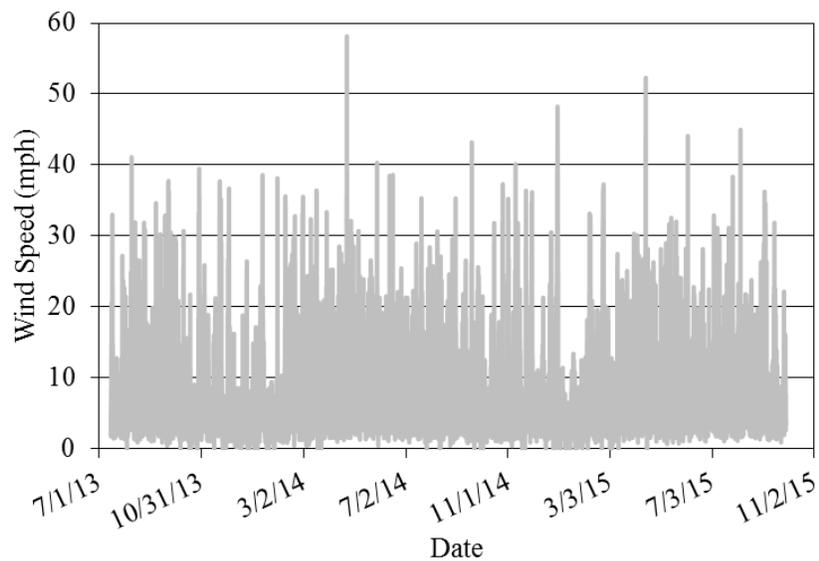
Figure A-23: Wind speed measurements from Campbell Scientific, Inc.

Figure A-23 shows wind speed data, also collected by Campbell Scientific, Inc. at their headquarters. Wind speed in this region varies throughout the year and is typically lower during the winter months.

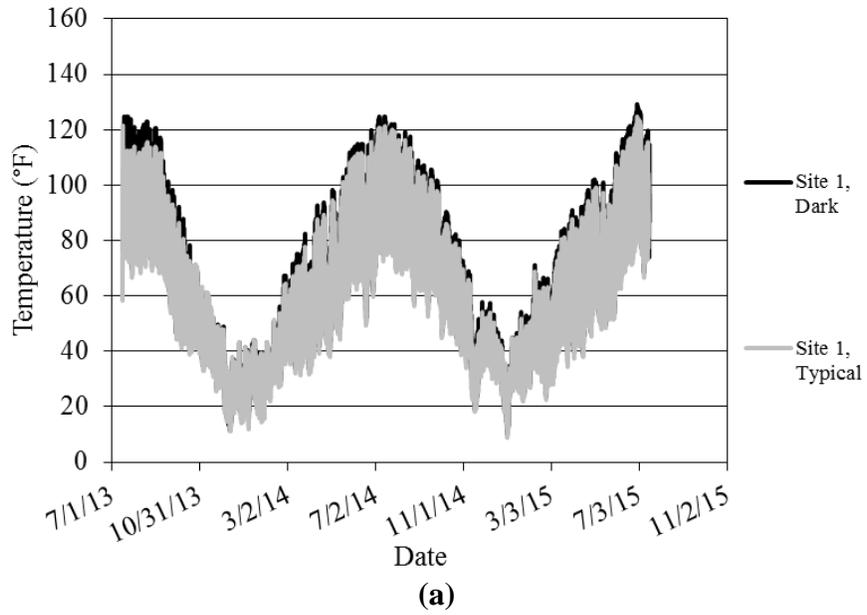
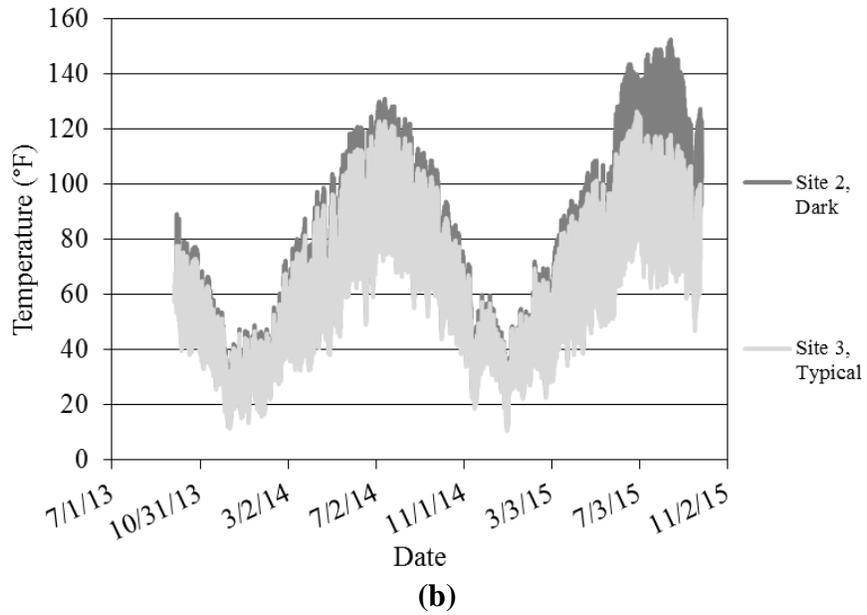
Figure A-24: Upper pavement temperature for (a) site 1 and (b) sites 2 and 3.

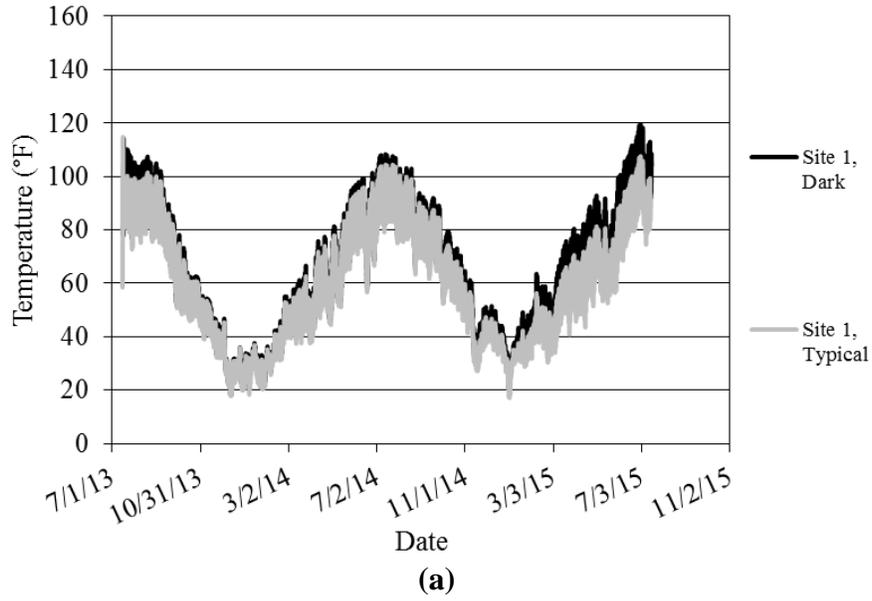
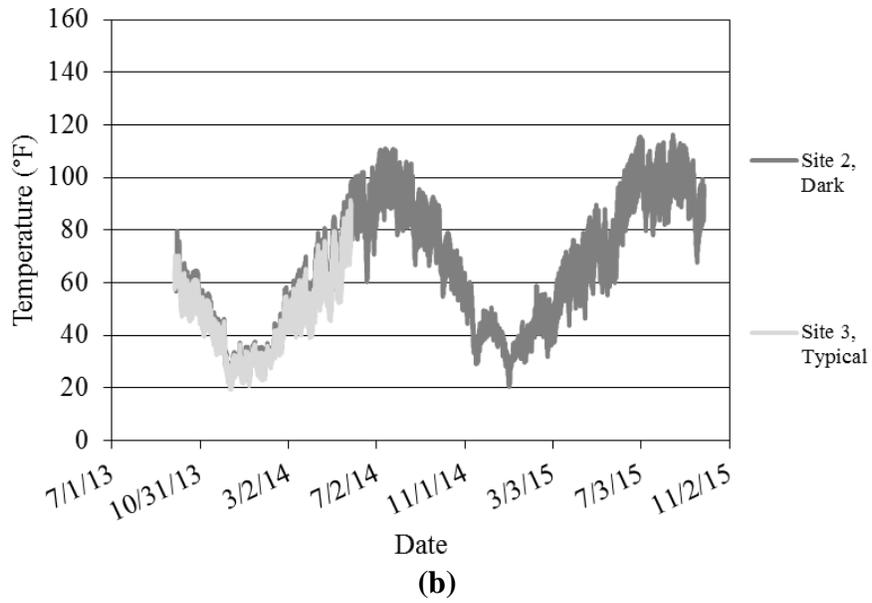
Figure A-25: Lower pavement temperature for (a) site 1 and (b) sites 2 and 3.

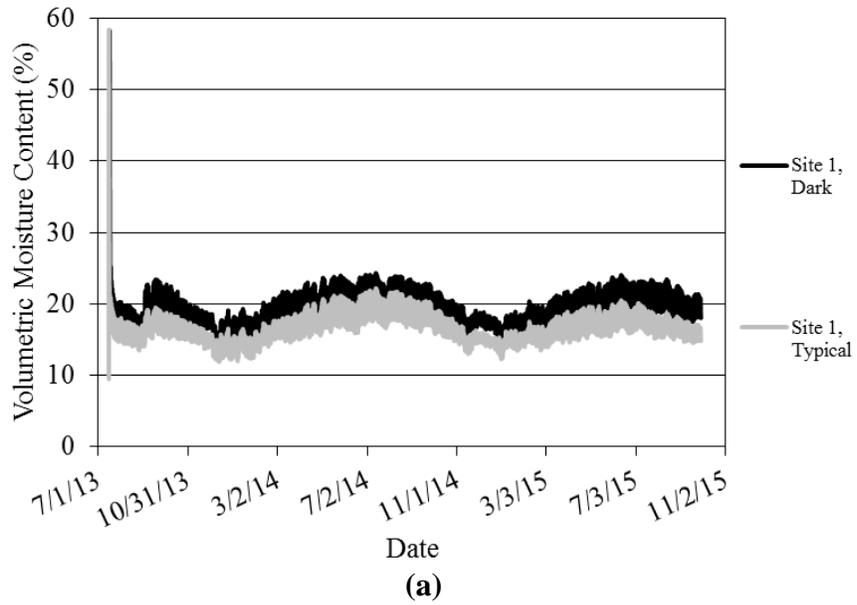
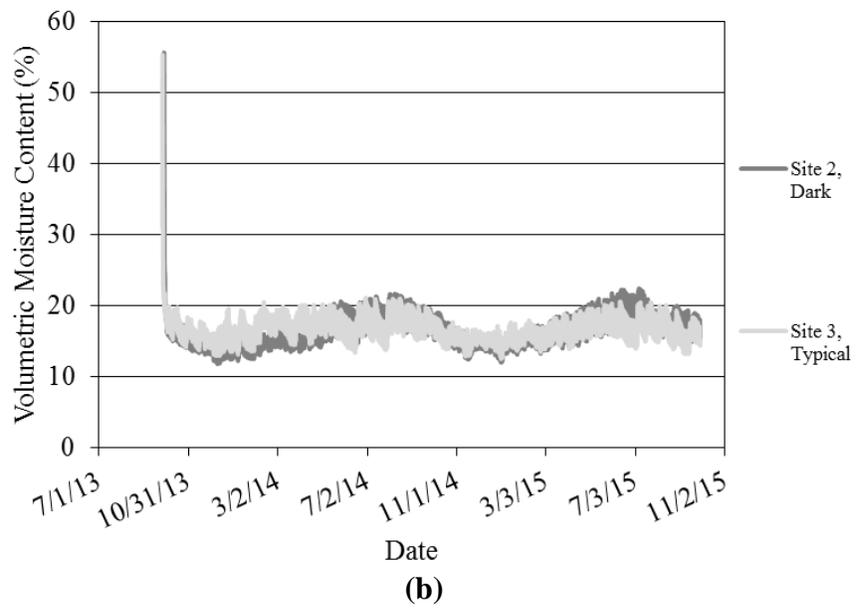
Figure A-26: Upper pavement moisture for (a) site 1 and (b) sites 2 and 3.

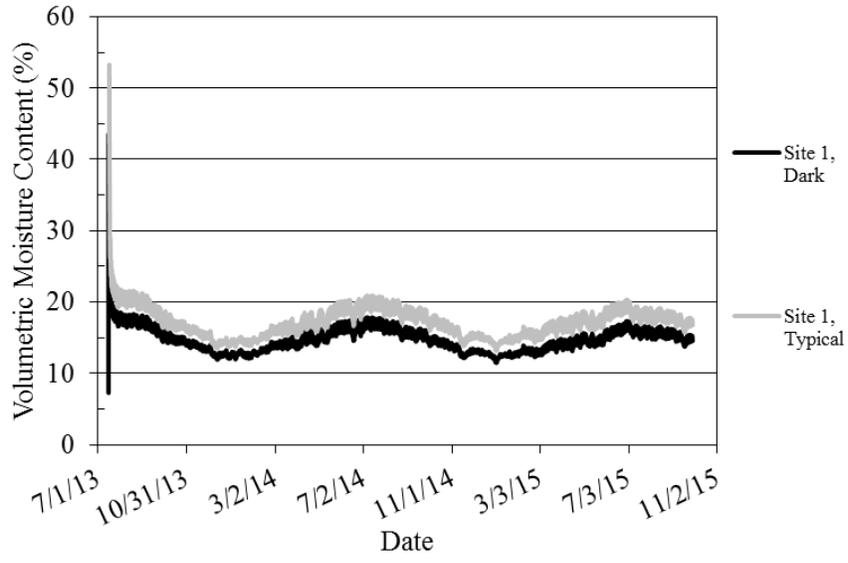
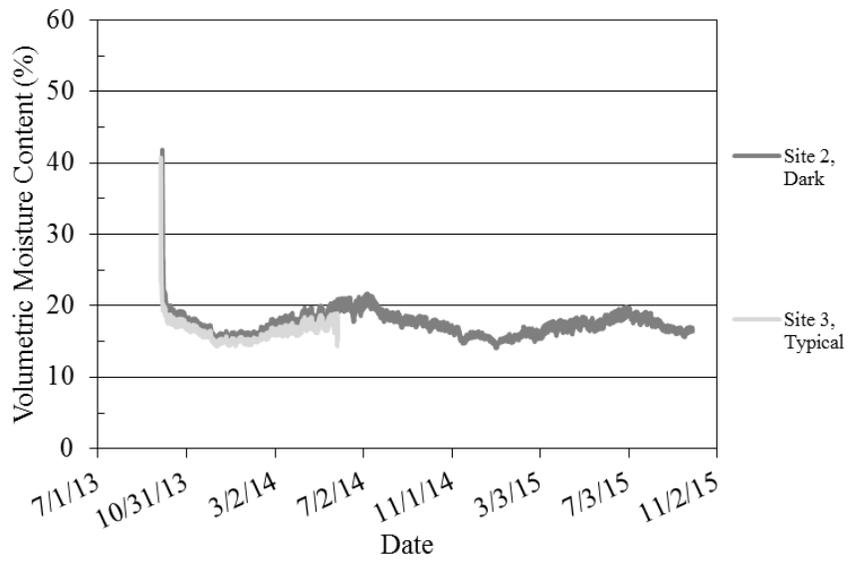
Figure A-27: Lower pavement moisture for (a) site 1 and (b) sites 2 and 3.

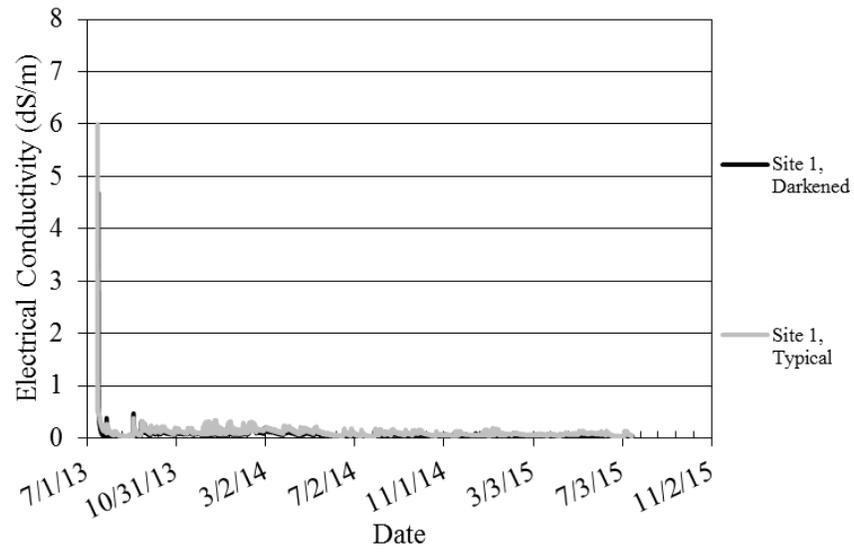
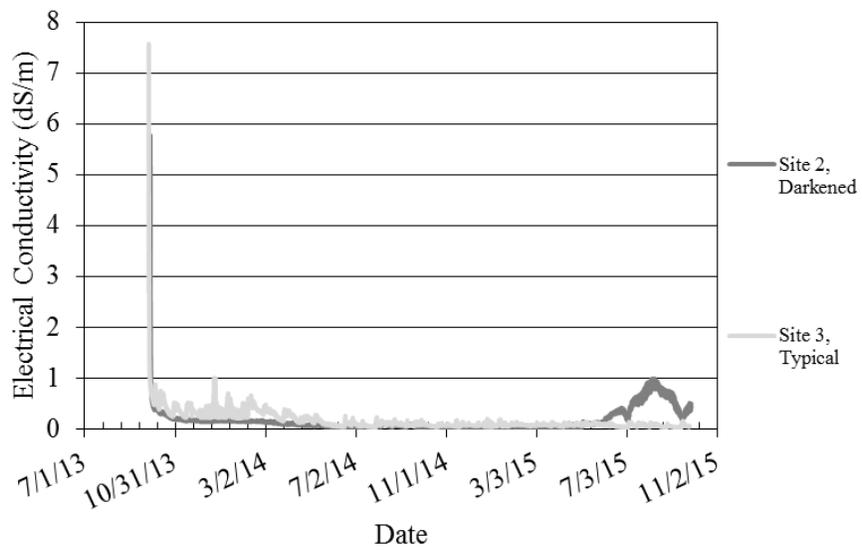
Figure A-28: Upper pavement electrical conductivity for (a) site 1 and (b) sites 2 and 3.

Figures A-28 and A-29 show the upper and lower pavement electrical conductivity, respectively, as measured by the embedded sensors. On average, there is no measurable difference in upper or lower electrical conductivity between the two types of concrete.

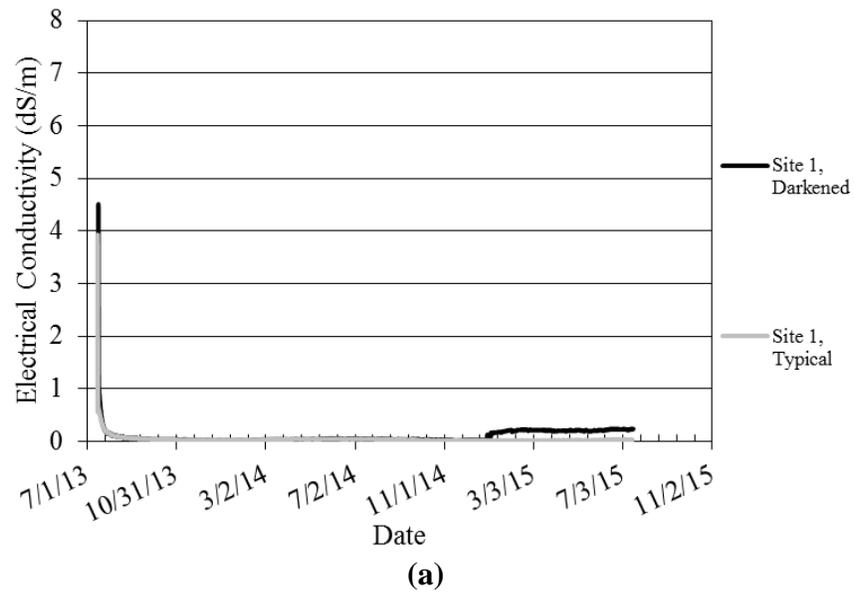
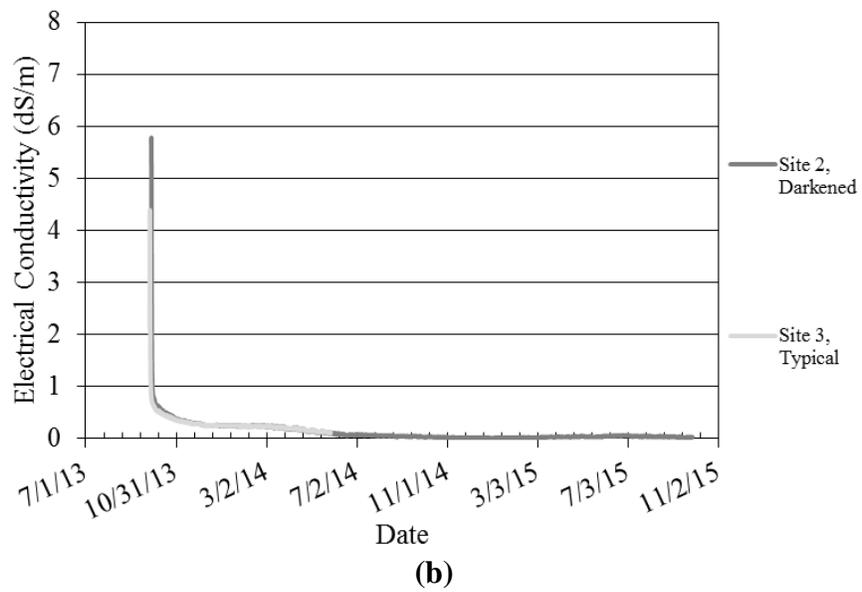
Figure A-29: Lower pavement electrical conductivity for (a) site 1 and (b) sites 2 and 3.
